CORROSION UNDER INSULATION (CUI)

A Nanotechnology Solution

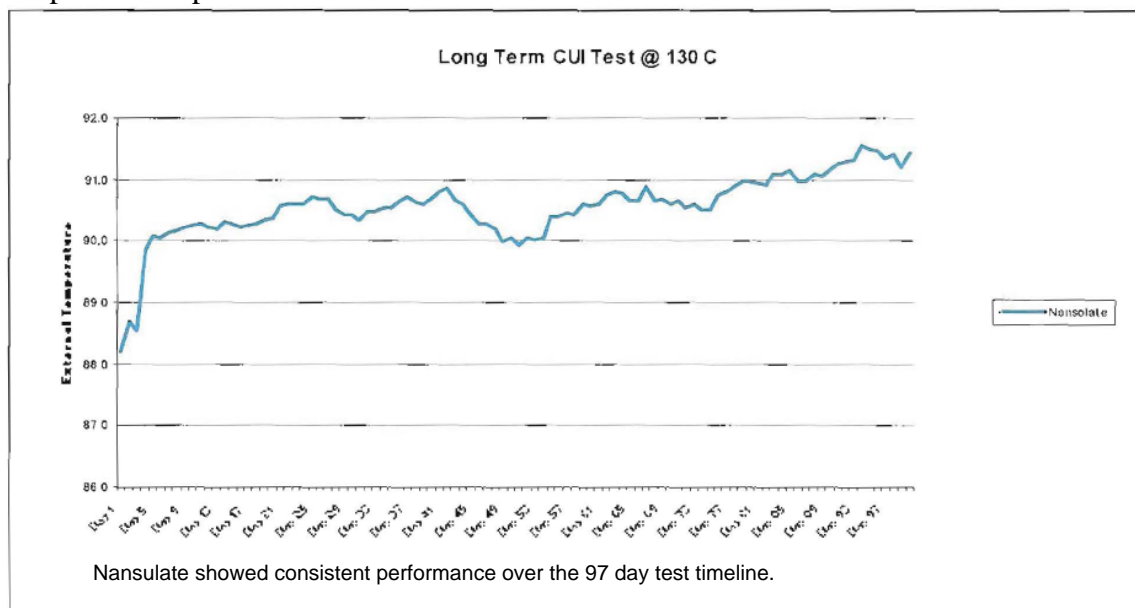
Graph: CUI exposure test

Resistance to CUI exposure at 130°C internal temperature

The externally coated pipe was filled with Shell Thermal B oil with four internal and four external thermocouples. One internal and one external thermocouple were positioned so they were at the same position to enable the measurement of the temperature difference. The sets of thermocouples were at different depth and equally spaced around the pipe. The oil was heated to 130°C and held for 100 days. During the 100 days the coating was sprayed with artificial seawater periodically over every 24 hours. Before the exposure test the coating has 020mm holidays milled through the coating to the substrate at three locations and saw cuts were made through the coating at the top and bottom of the cornered joint.

CUI Exposure Test	
Test Specification BC/BP/JC issue 1 revision C	
Result	
After completing the exposure the coating exhibited no visible signs of cracking, flaked or disbondment.

CUI Exposure Test		
Rating Assessment After Exposure		
Test Specification	Assessment	Rating
BS 3900 Part H2	Degree of Blistering	2(S4)
BS 3900 Part H3	Degree of Rusting	Ri3 (less than 1%)
BS 3900 Part H4	Degree of Cracking	0(0)
BS 3900 Part H5	Degree of Flaking	0(0)

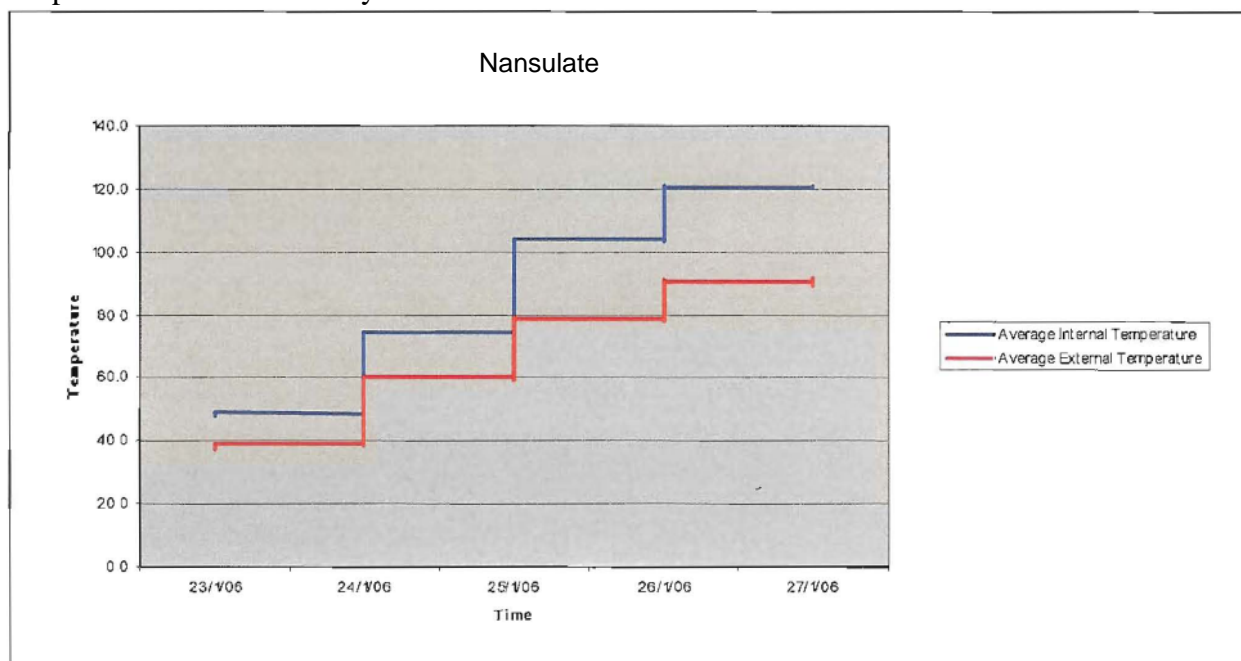
Graph: Thermal conductivity test

Thermal conductivity exposure 60°C to 130°C

The externally coated pipe was filled with Shell Thermal B oil with four internal and four external thermocouples. One internal and one external thermocouple were positioned so they were at the same position to enable the measurement of the temperature difference. The sets of thermocouples were at different depth and equally spaced around the pipe. The oil was heated to 60°C and held for 24 hours then increased to 90°C and held for 24 hours then increased to 110°C and held for 24 hours then increased to 130°C.

Thermal Conductivity Test	
Test Specification BC/BP/JC issue 1 revision C	
Result	
After completing the exposure the coating exhibited no visible signs of cracking, flaked or disbondment.
